2009 WBA Remodeling Awards

**Project Category:
Room Additions over \$75,000**

DEGNAN
DESIGN BUILDERS
INC.

**“A Cut Above The Rest”
Award Winning Entry!**

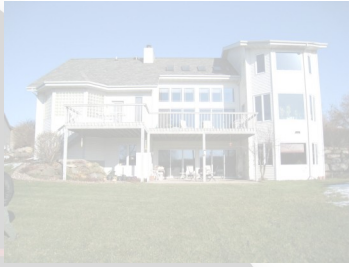
Right: Before, the old patio and walk-out lower level are shown during previous years flooding.

This 3-season sunroom addition posed many challenges and many changes as it developed. The original home, located in a suburban neighborhood, had a full walk-out basement looking out toward a small river about 50 yards away. The homeowners wished to alleviate flooding concerns should the river overflow its banks further than in the past. After debating options such as building a 4-season addition or eliminating the patio doors and installing only windows, the customers decided that a sun porch was the best option.

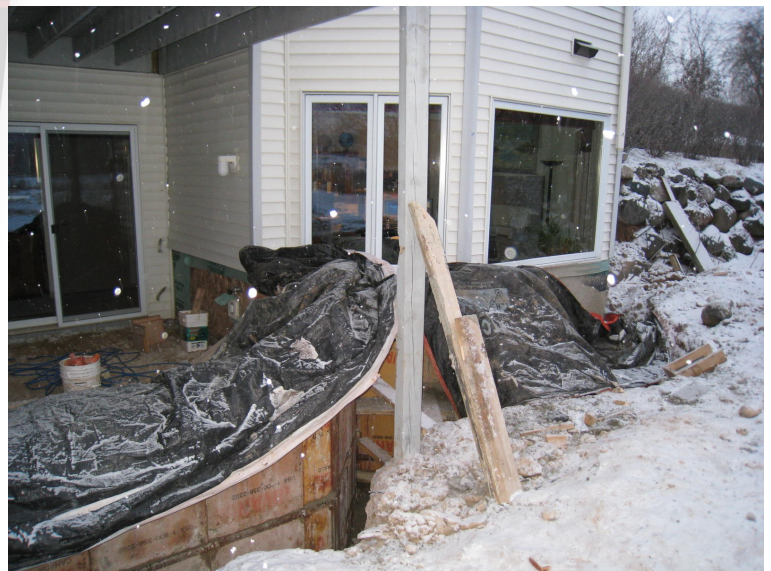
Left: The deck surface with Ditra prepped for tile installation.

The existing deck structure was actually re-used to become the roof of the room below. The shape was modified to create octagonal corners to flow with the theme of the octagonal dinette on the existing home. The next challenge was to waterproof this deck roof. Degnan Design Builders elected to treat it much like a shower, using Schluter products, with an exterior

porcelain tile installed over a layer of cement board and $\frac{3}{4}$ " plywood. The multiple layers ensure stability to prevent tile or grout cracking and ensure a waterproof deck/roof surface for years to come. Meanwhile, the Lead Carpenter made repairs to the joist hangers and fasteners. He installed a new beam system and posts over the new foundation to slope the deck surface away from the house for proper drainage of rain and snowmelt.

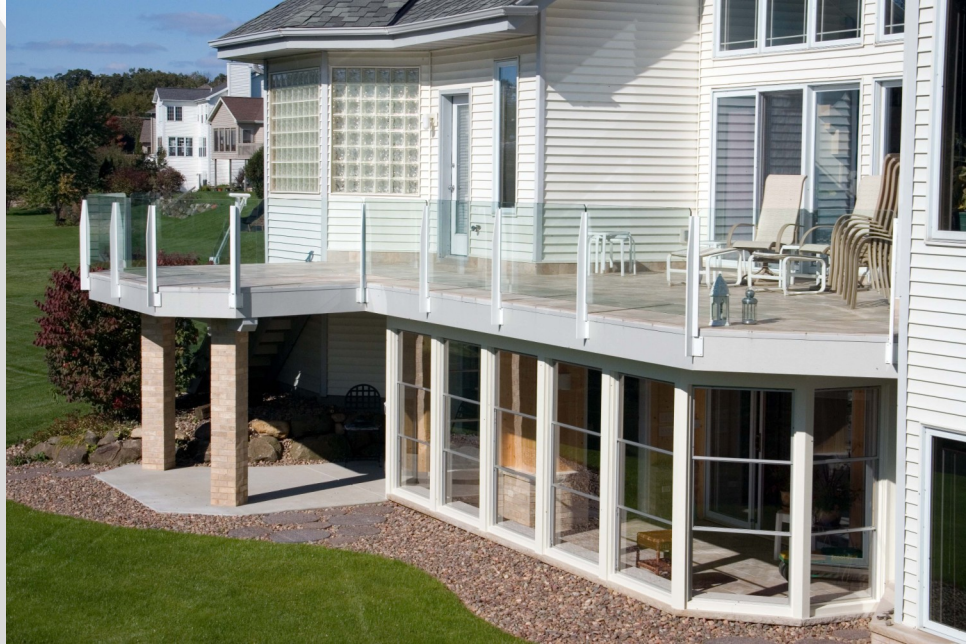
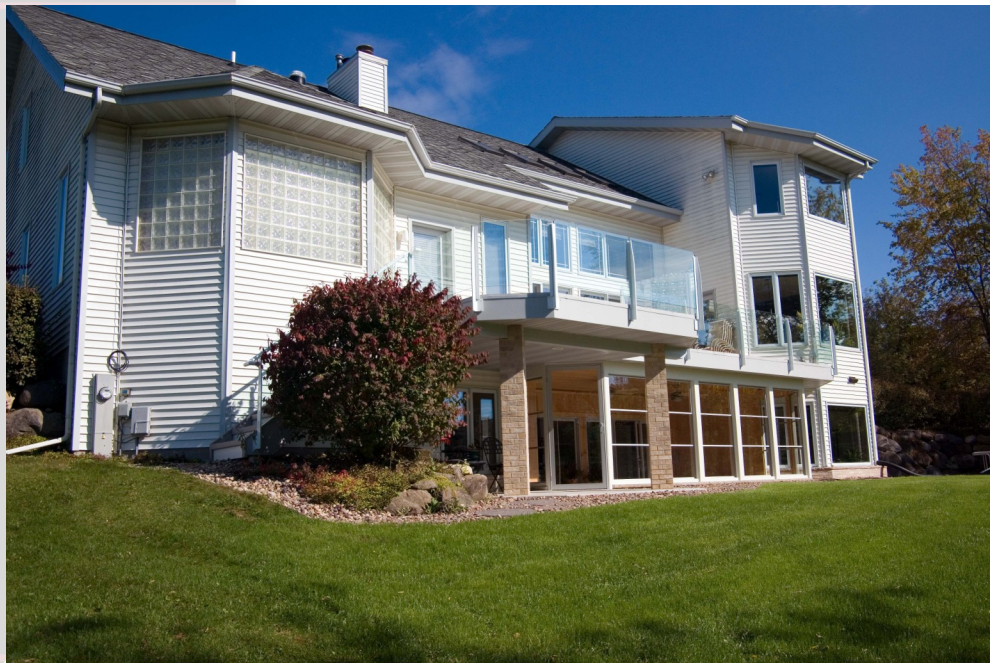
Below: Two photos of the finished project with its glass deck railings, Mon-Ray windows, and masonry columns which also match interior masonry of the sun porch.

The aesthetics were paramount— both from inside and outside. The full Mon-Ray Glasswalls windows preserve the views from the lower level of the home. The main level views have improved thanks to a glass railing from RailCraft. A small outdoor patio remains under the waterproofed deck, adjacent to the sun porch. The deck roof provides a small overhang to prevent excessive heat gain during summer months while still allowing for sun rays to penetrate deeply in the spring and fall. The ceiling was made into a “hot roof” with 10” of dense-packed cellulose insulation. Foam insulates the floor slab and foundation in case of a future conversion to a 4-season sunroom. These design and insulation techniques also help to ensure the room stays as comfortable as possible, for as long as possible.
